# FDN4 Penetration of Plasterboard Fire Walls

# STRUCTURAL STEEL MEMBERS PENETRATION OF PLASTERBOARD FIRE WALLS

by I. D. Bennetts<sup>1</sup>, K. Moinuddin<sup>2</sup> and D. J. Proe<sup>2</sup>

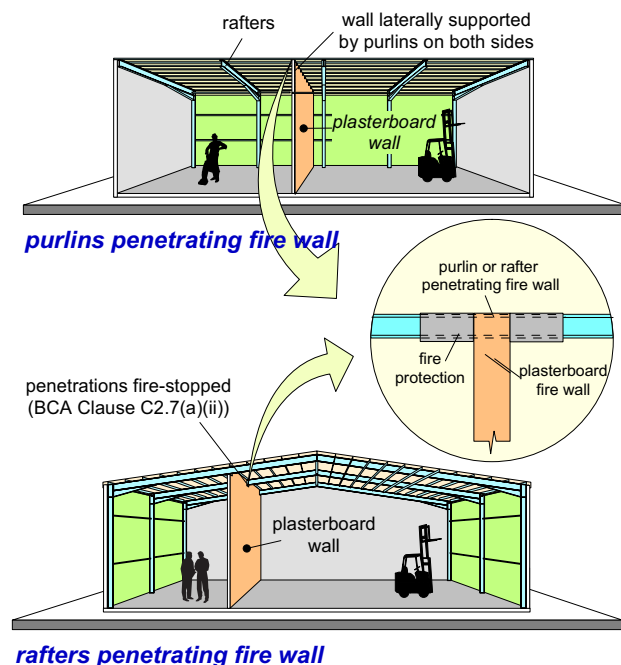
Figure 1

It is common for structural steel members to penetrate fire-resistant walls. The most common situation is where a steel frame or supporting column is located within a fire-resistant plasterboard wall and other steelwork such as purlins or beams must frame into this supporting steelwork. Inevitably, this results in steel members penetrating the envelope of the wall. Since steel is a good heat conductor, it is traditionally assumed that fire may spread between compartments due to excessive heat flow via the penetrating steel member. In the past measures have been taken to avoid this possibility, with penetrating members being fire-protected on each side of the wall. This can be expensive. Two situations are illustrated below.

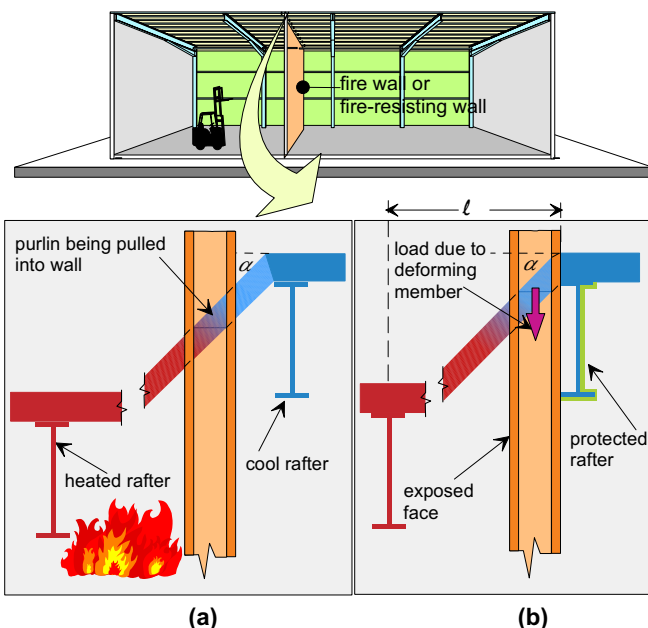
Figure 3

If the plane of a wall is perpendicular to the purlins, deformation of the purlins and rafters on the fire side of the wall may be sufficient to drag the purlins downwards into the wall as illustrated below.

- (i) locate the wall directly adjacent to a protected rafter (see Figure 3(b)) and allow sufficient space below the purlins for some movement (see detail in Figure 4(a)). The rafter adjacent to the fire wall must be protected, since fire may occur either side of the wall, or
- (ii) incorporate steelwork within the wall capable of resisting the loads applied to the top of the wall. In this case the rafter does not need to be protected.

Assume that the purlin is supported by a rafter adjacent to the wall as per Figure 3(b) and that it is discontinuous at all rafter supports, attached to each rafter by two bolts. As the roof on the fire side of the wall is heated, the purlins will tend to heat more rapidly than the rafter due to their thinner steel section. They will thus expand and remain slack until the rafter deflects sufficiently for this slack to be absorbed. At this time the force in the purlin will increase rapidly, with shear failure of the heated bolts occurring shortly thereafter. The vertical component of the axial force in the purlin at this time will be the maximum force applied to the supporting structure. Assuming purlins and bolts to be at a temperature of 800°C, the angle to the horizontal ( $\alpha$ ) and the vertical component of the reaction force ( $P$ ) can be calculated as follows:

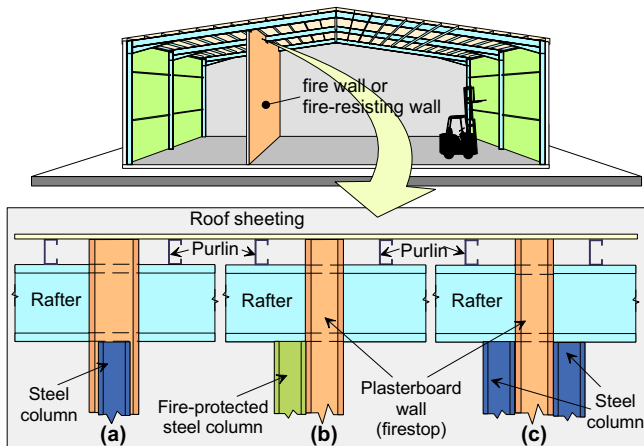
Figure 5

The second situation is where a unprotected steel rafter penetrates a wall (Figure 5). In this case, the structural adequacy of the wall can be achieved by:

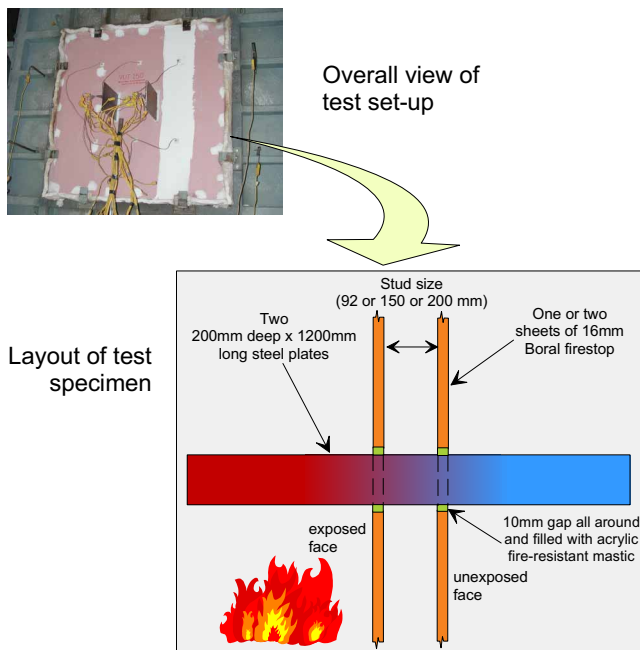
Figure 6

The tests were conducted in a fire test furnace which internally measures 2.1 m (width) x 1.8 m (depth) x 2.1 m

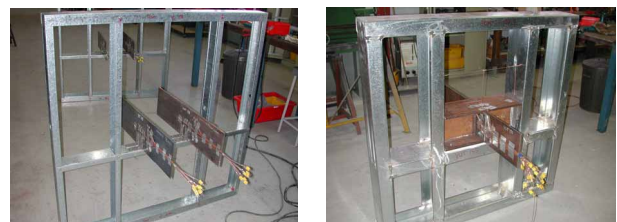
Figure 7

Six specimens were tested, three with a single layer of plasterboard on each side and three with two layers on each side (see Figure 7(a)). In all tests, the plasterboard used was 16mm Boral Firestop. The specimens with a single layer were tested to 120 minutes, while those with two layers were tested to 180 minutes. In practice, the single layer system is typically used to achieve an FRL of -/60/60, while the double layer system is used to achieve an FRL of -/120/120.

In addition to the above, one further test was conducted in which a steel member of size 200UC46 was encased within the wall, representing a rafter. A penetrating plate of 12 mm thickness was attached to each side of this member. Two layers of plasterboard were used on each side. This arrangement is illustrated in Figure 7(b).

(a) Two Penetrating Plates (b) Specimen with rafter

From the test conducted with the rafter placed within the wall cavity (Figure 7b), the unexposed face temperature was lower than for the corresponding tests described above. This was due partly to some heat being absorbed by the additional steel member and partly to the greater internal wall thickness, which was 200 mm in this case (compared

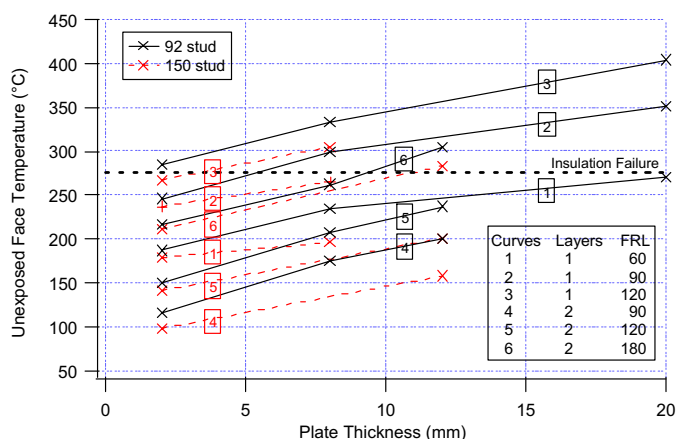
**Figure 8**

The relevant test results are summarised in Figure 8, which shows the measured unexposed face temperature versus thickness of penetrating plate at various times of fire exposure between 60 minutes and 180 minutes. The adopted insulation failure temperature of 275°C is also shown in this figure.

For the smaller stud size and a single layer of plasterboard, it may be seen from Curve 1 in Figure 8 that at 60 minutes all plate thicknesses up to 20 mm gave acceptable performance, with the unexposed face temperature below the adopted insulation failure temperature. Curve 2 shows that acceptable performance can be achieved at 90 minutes for plate thicknesses up to 6 mm.

For two layers of plasterboard, Curve 5 shows that acceptable performance at 120 minutes was achieved for plate thicknesses up to the maximum tested value of 12 mm. Since Curve 5 is below Curve 1 at this point, it seems reasonable to extrapolate these results and conclude that satisfactory performance will be achieved for plate thicknesses up to 20 mm. At 180 minutes, acceptable

performance was achieved for plate thicknesses up to 9 mm, as shown by Curve 6.

It may be seen from Figure 8 that the larger stud size produced lower unexposed face temperatures in all cases. However, these differences do not provide significant benefit near the limiting insulation temperature, and it is suggested that this effect be ignored.
